# Performance of Strip Seals in Iowa Bridges, Pilot Study

FINAL REPORT

Iowa Highway Research Board  
Project TR-437

Iowa State University

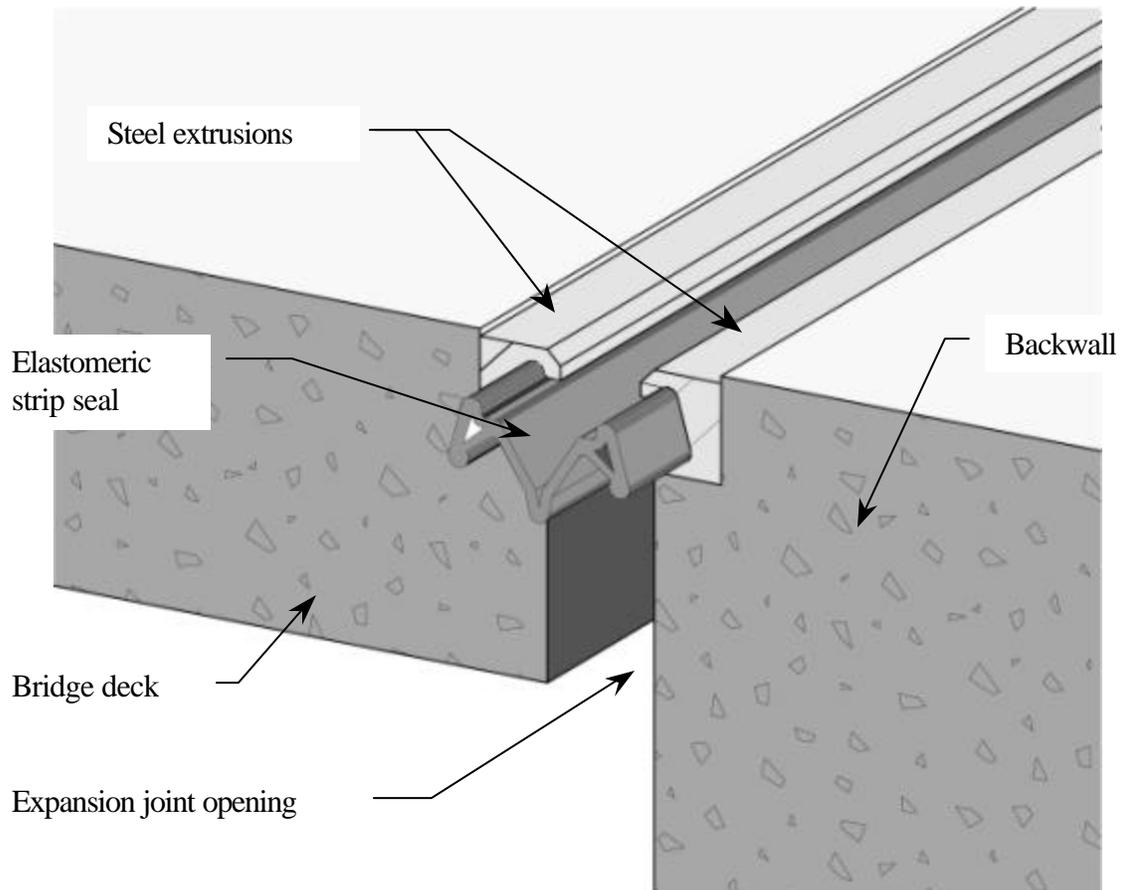
**Figure 1.1** Typical strip-seal expansion joint device

Expansion joints are used in bridges to allow expansion and contraction of the bridge superstructure due to temperature changes. In order to prevent salt, water and debris from passing through the expansion joint opening and reaching the bridge substructure, a seal or trough is required in the expansion joint opening. A strip-seal expansion joint device is one alternative for this function. It consists of a pair of steel retainer rails (steel extrusions), a polychloroprene (neoprene) gland and lubricant/adhesive material to facilitate the installation of the gland and to seal the gland in the extrusions.

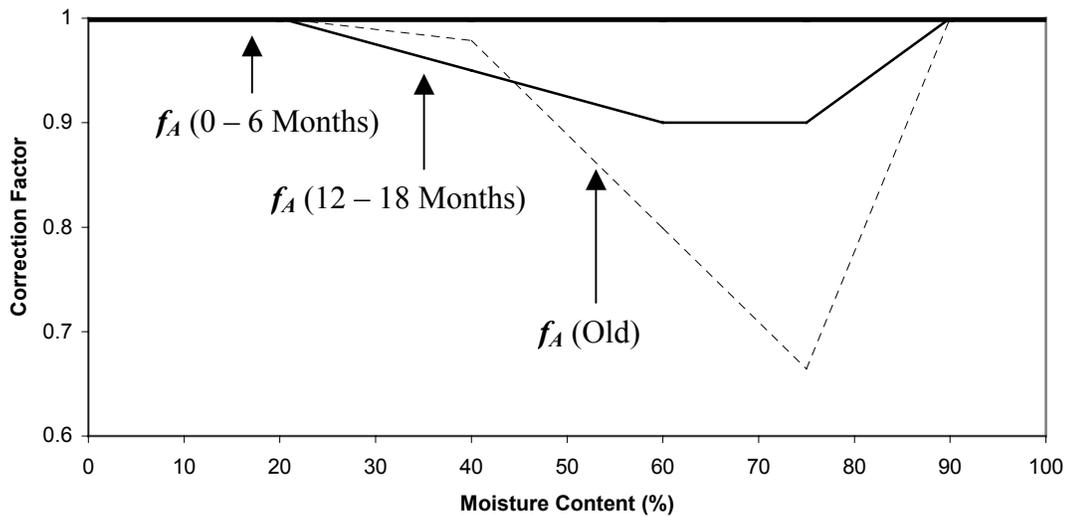
Figure 2.2 Correction Factor for  $f_A$  (adapted from [3])

These researchers stated that the aggregates occupy approximately 70% to 80% of the volume of the concrete. If the actual aggregate volume is not known, aggregates can be assumed to occupy 75% of the total volume with 30% of that aggregate volume considered as fine aggregates. Emanuel and Hulsey concluded that: (i) the  $\alpha$ -value of concrete is

dependent upon the volumetric weighted average of the ingredients, (ii) the  $\alpha$ -value of concrete is the least at the saturated condition, is slightly higher at the oven-dry condition, and is the highest at a partially dry condition (about 15% higher than for the saturated condition), (iii) the  $\alpha$ -value of concrete increases with the richness of the mix and decreases with repeated temperature variations, and (iv) an increase in the amount of aggregate will decrease the moisture effect on the  $\alpha$ -value of concrete.

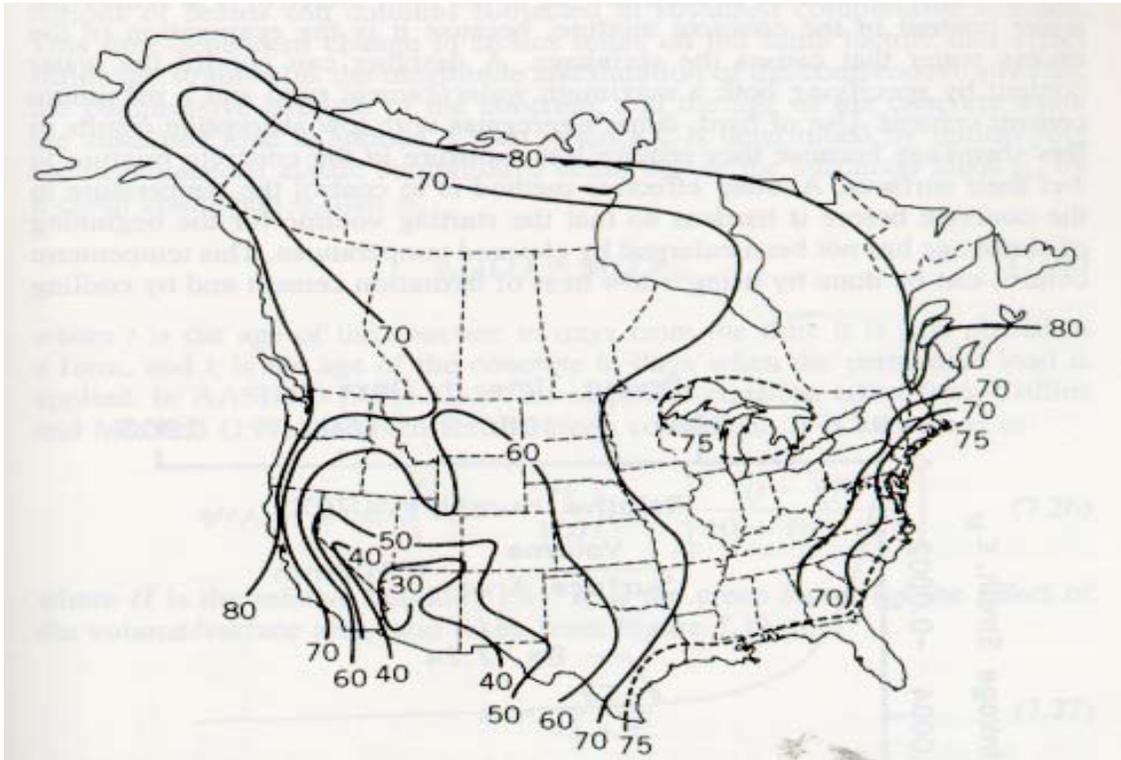
Figure 2.3 Annual average ambient relative humidity in % (Adapted from [7])

$k_h$  = humidity factor specified in Table 2.9 and Figure 2.3,

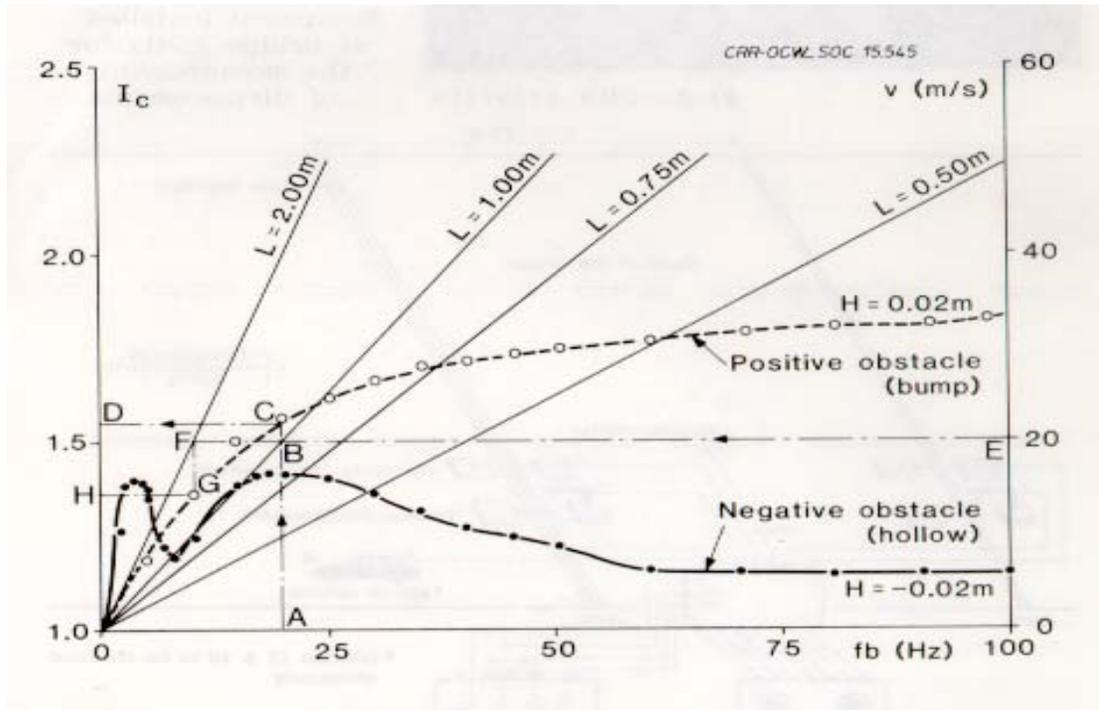
Figure 2.4 Determination of dynamic amplification factor (adapted from [22])

$I_c$  = dynamic amplification factor (Figure 2.4).

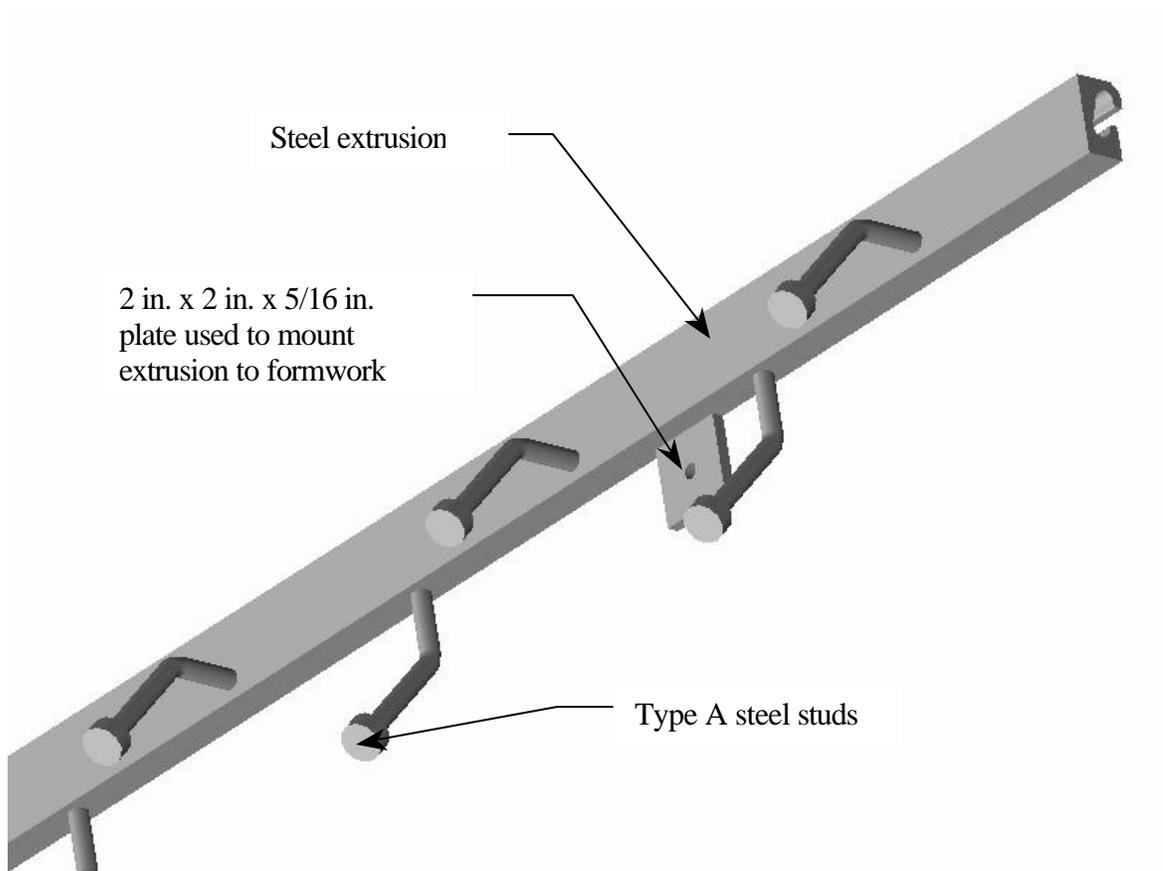
Figure 3.2 Typical configuration of steel extrusions as used in South Dakota.

The South Dakota DOT permits the use of A36, A242, or A588 steel for the rails. The small steel plates welded to the bottoms of the rails for purposes of mounting the rails to the formwork, however, are to be of A36 steel and the concrete anchors are to be Type A Steel Studs (Figure 3.2). South Dakota requires that, before installation, the shop plans of the proposed strip seal showing the fixed dimensions, thickness of the seal, and dimensions pertinent to the fit of the seal in the extrusion be submitted to and approved by the engineer.

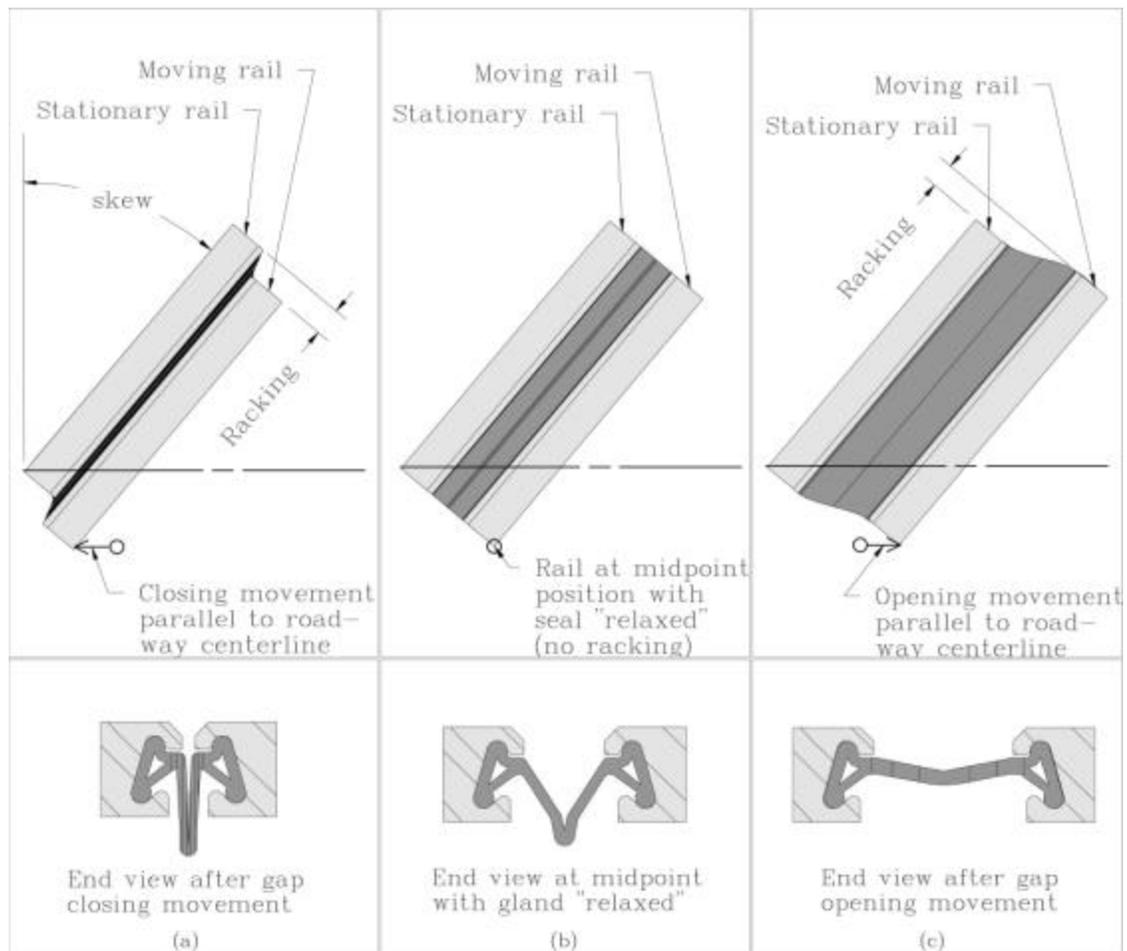
FIGURE 3.4 For large skew angles, movement includes a significant racking component which decreases the effective movement range of the neoprene gland.

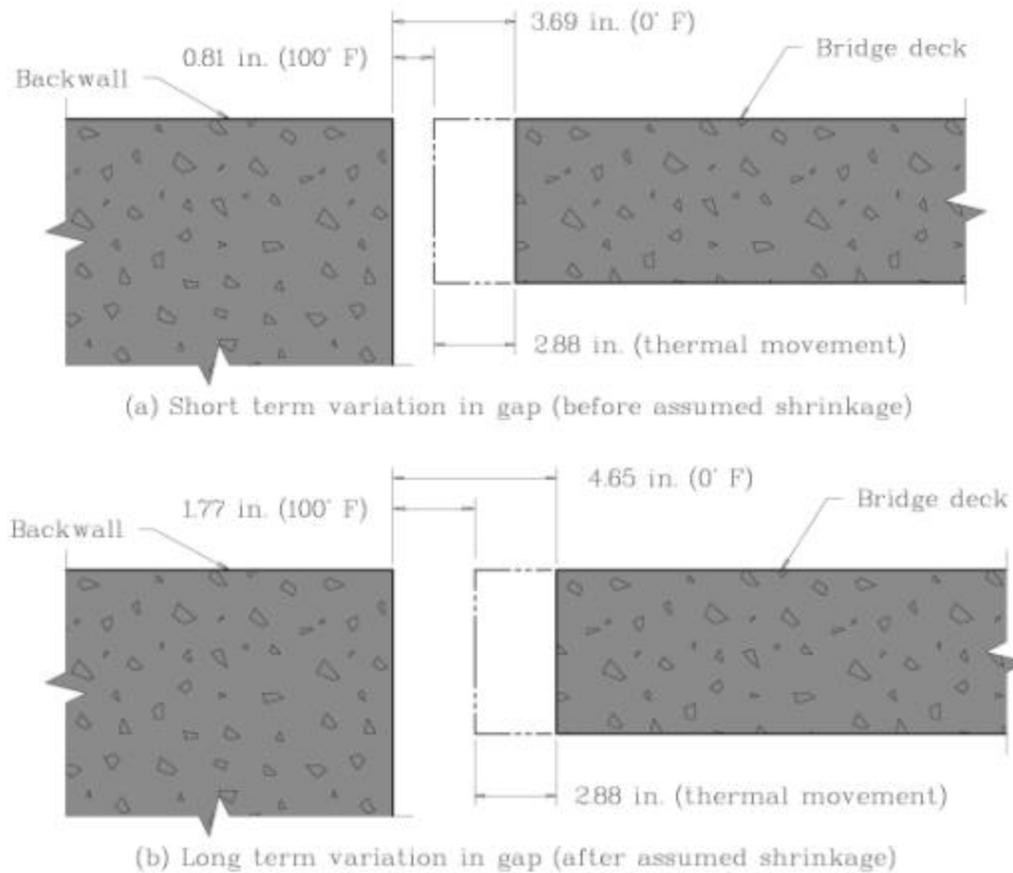
Figure 3.5 Predicted gap variation with and without the effects of shrinkage

These long-term minimum and maximum gaps are illustrated in Figure 3.5(b). The gap variation due to thermal effects is still 2.88 in. However, because of shrinkage effects, the maximum gap (i.e., the gap at 0° F) is now 4.65 in., which is considerably larger than the 4 in. maximum opening rating for the SE400 gland.

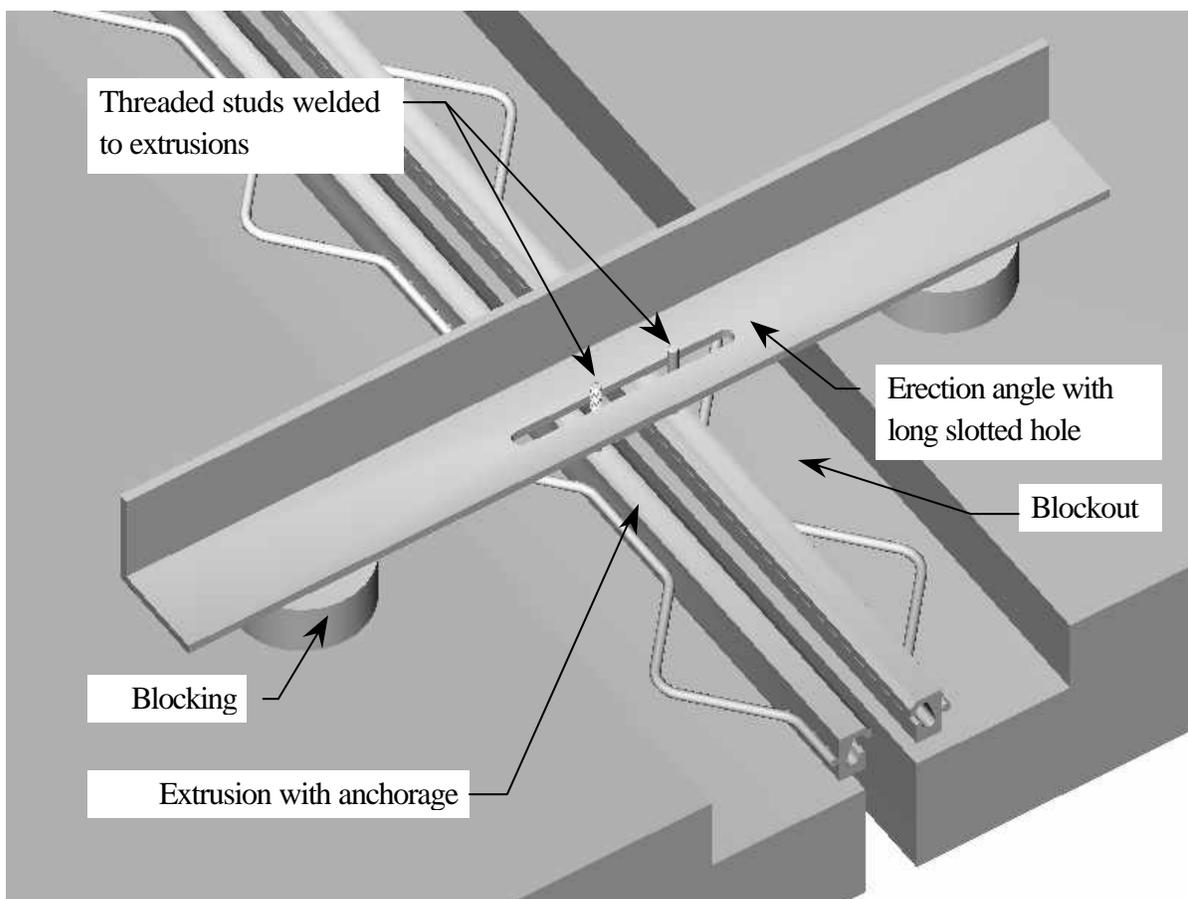
Figure 4.1 Computer model of extrusions positioned in blockouts using an erection angle

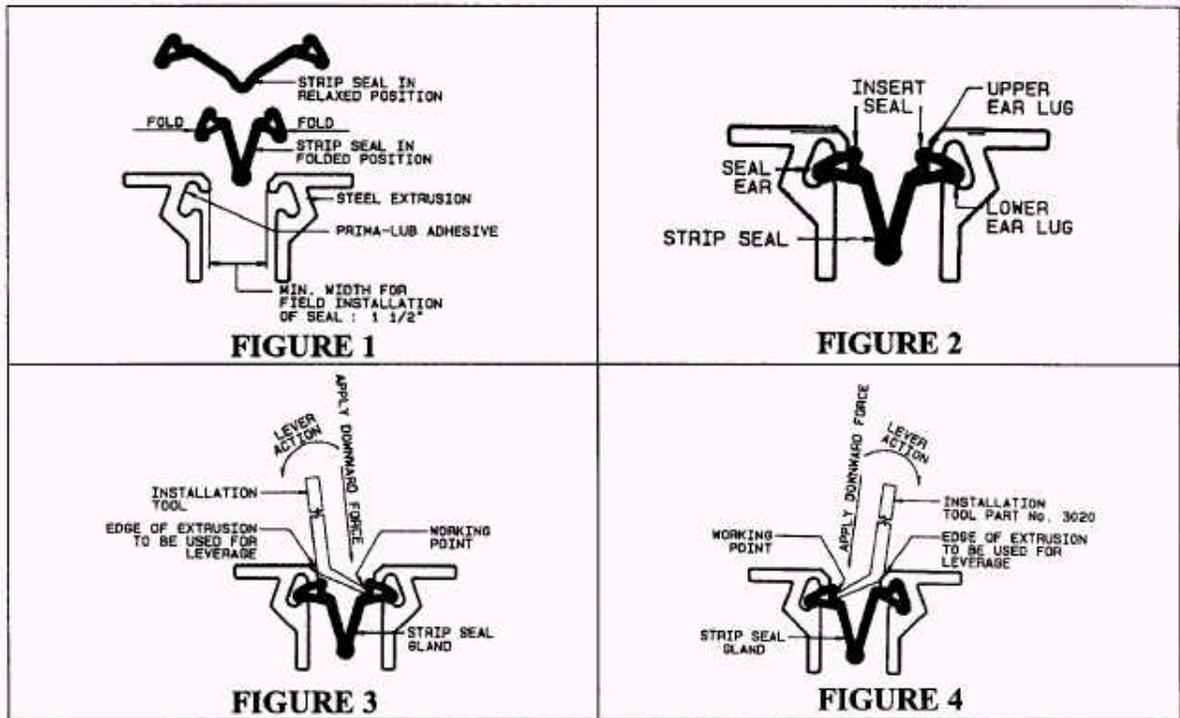
Figure 4. 2 Figures from Watson Bowman Acme to illustrate the seal installation steps

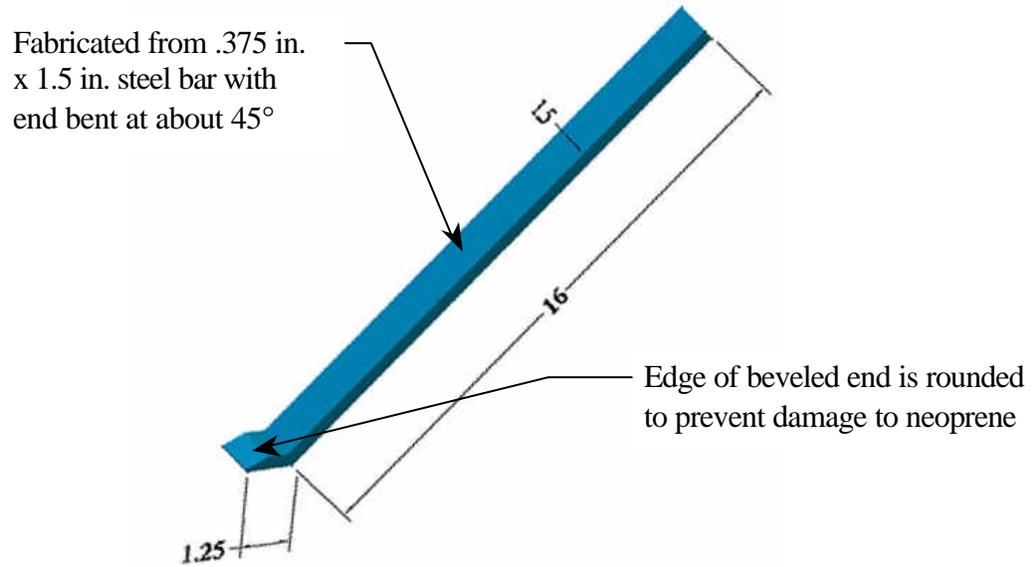
Figure 4.3 Installation tool similar to that available from Watson Bowman Acme

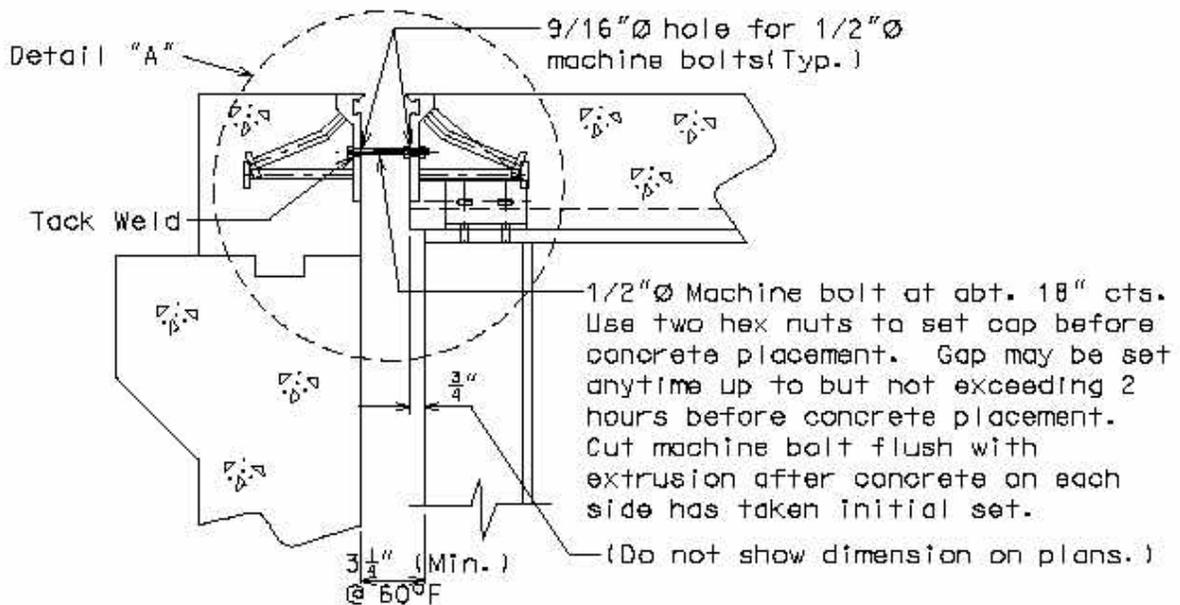
Figure 4.4 Mechanism used in Missouri for setting the gap with P-type extrusions

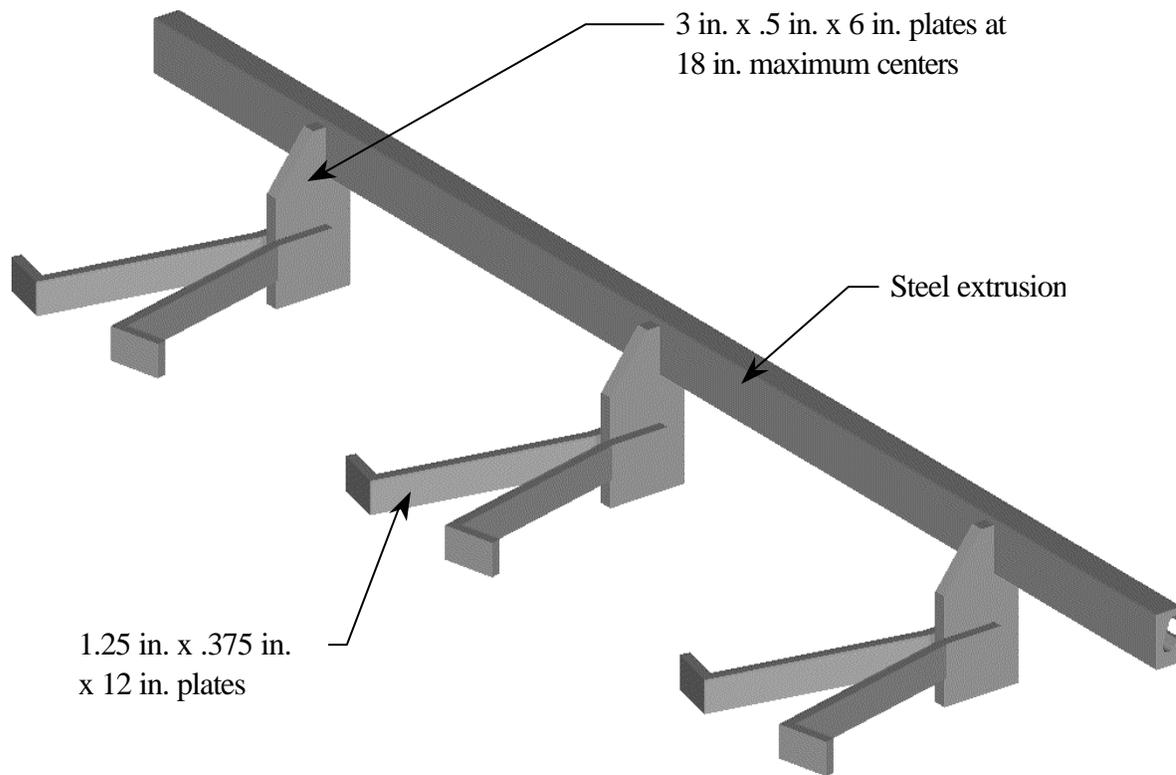
Figure 4.5 Model of the extrusion with anchorages of the type used in Iowa

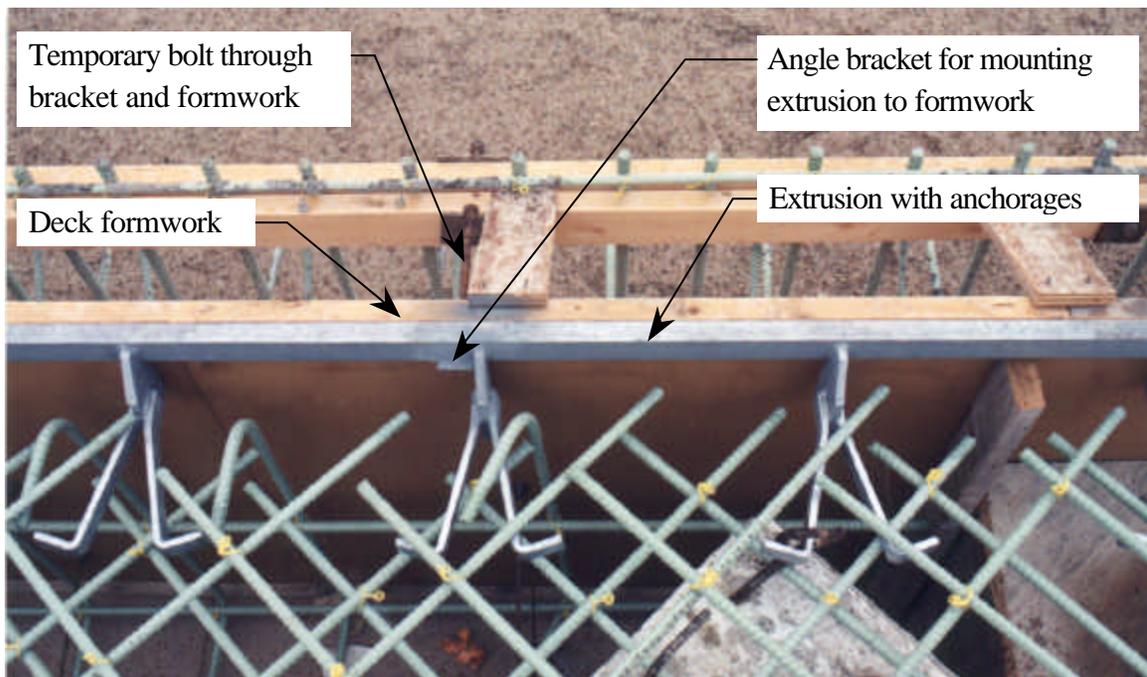
Figure 4.7 Rail section with anchorages positioned and bolted to deck formwork

Sometime after the deck rails are installed, the deck is poured and the anchorages and bottom and deck-side of the rail are encased in concrete (Figure 4.13). After adequate curing time for the deck concrete (usually about a week), the deck formwork is stripped and forming of the backwalls begins. Once the formwork for the backwalls is complete, the rail sections on the backwall sides are positioned, attached to the backwall formwork, and welded together in a manner like that used for the rails on the deck side of the expansion joint. There is very limited space available between the deck and backwall formwork for connecting the rails to the formwork. On the Highway 5 bridge, small angle brackets with short bolts were welded to the bottom of the rail sections for this purpose (Figures 4.7 and 4.10).

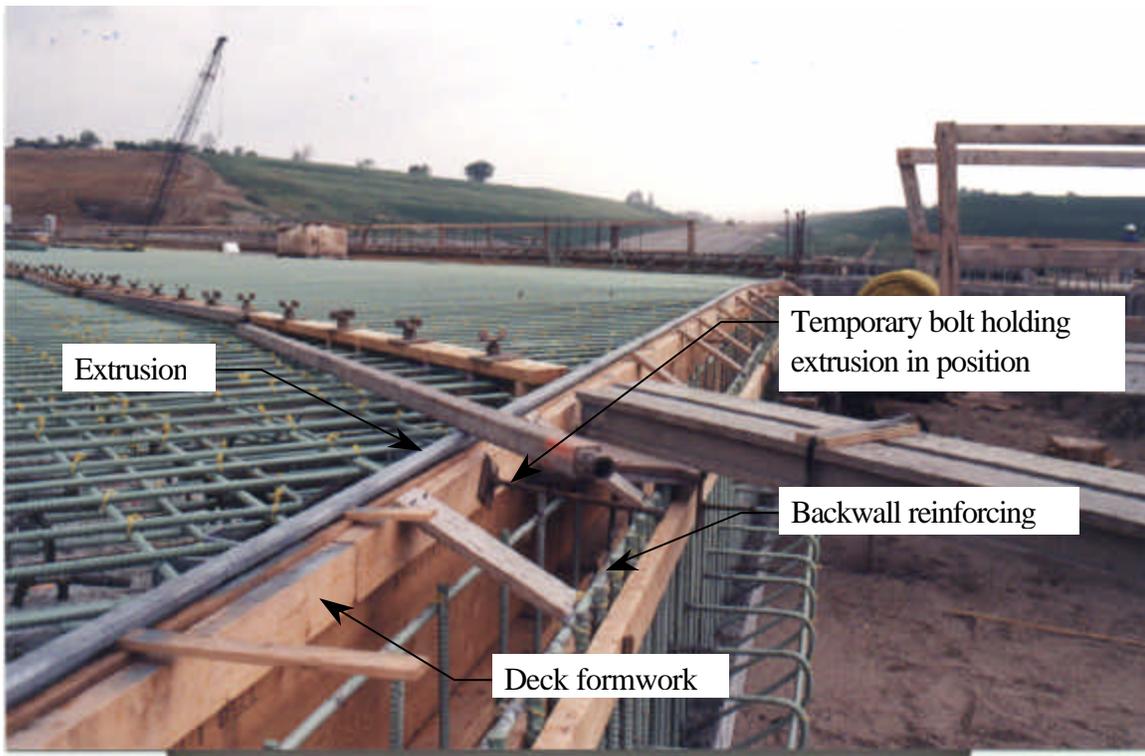
Figure 4.8 Extrusion at one end of deck installed from gutter to gutter

The rail sections are then welded together as necessary on site. For example, on the IA Highway 5 bridge, the rails at either end of the deck were installed first (there were no intermediate joints in this bridge). Starting at one side of the bridge, a gutter section (rail section with upturn – see Figure 3.3) was positioned and attached to the deck formwork with temporary bolts (Figure 4.7). A second section was then positioned adjacent to the first, bolted to the formwork, and welded to the first across the top, back (deck side), and bottom of the rail. Additional rail sections were positioned and welded in a similar fashion to complete the rails at either end of the deck (Figure 4.8).

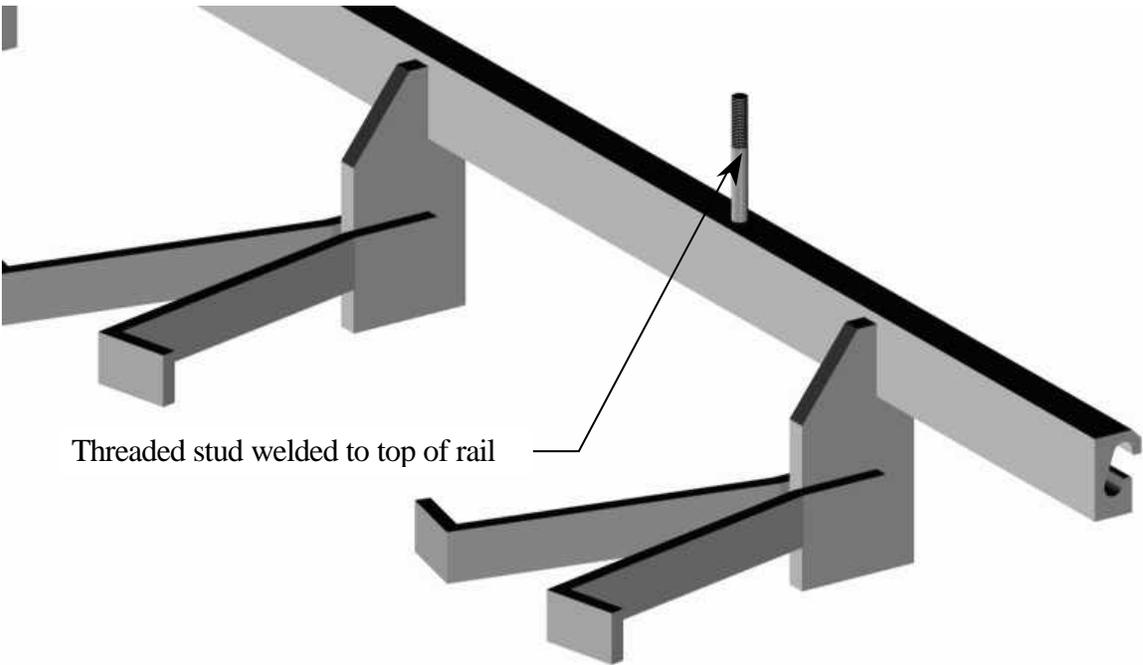
Figure 4.9 Threaded studs are one mechanism used to hold rails in position (see Figure 4.1)

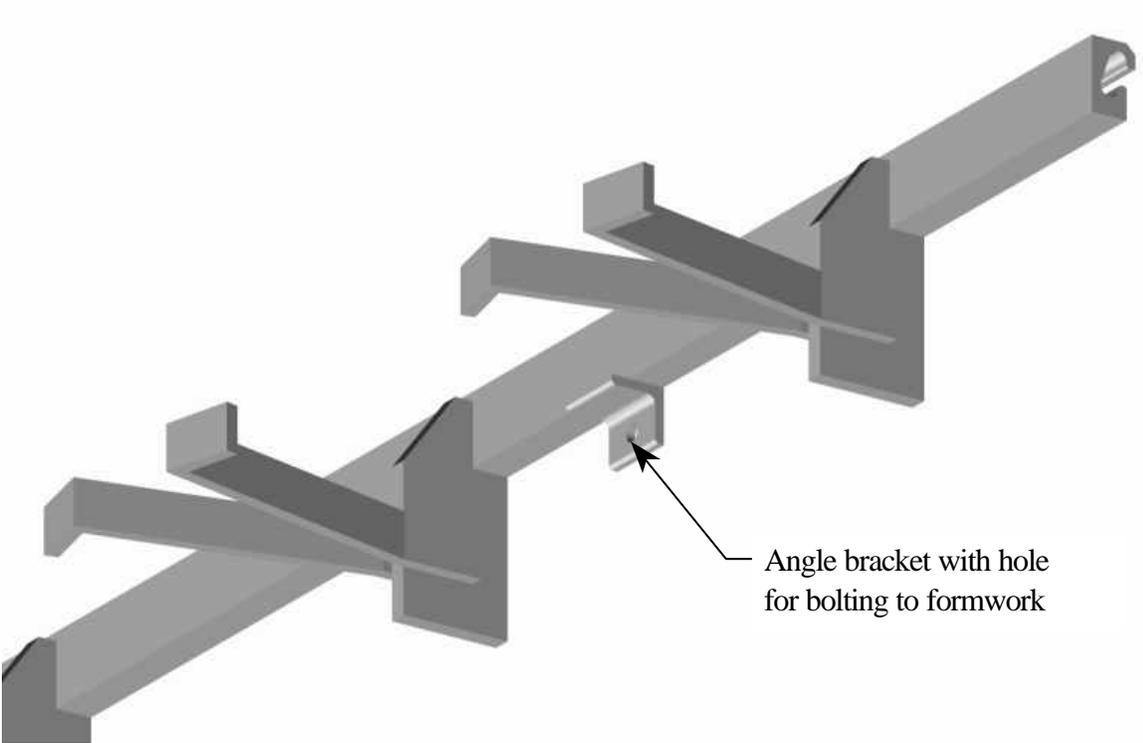
Figure 4.10 Model of extrusion with angle bracket for mounting welded to bottom surface

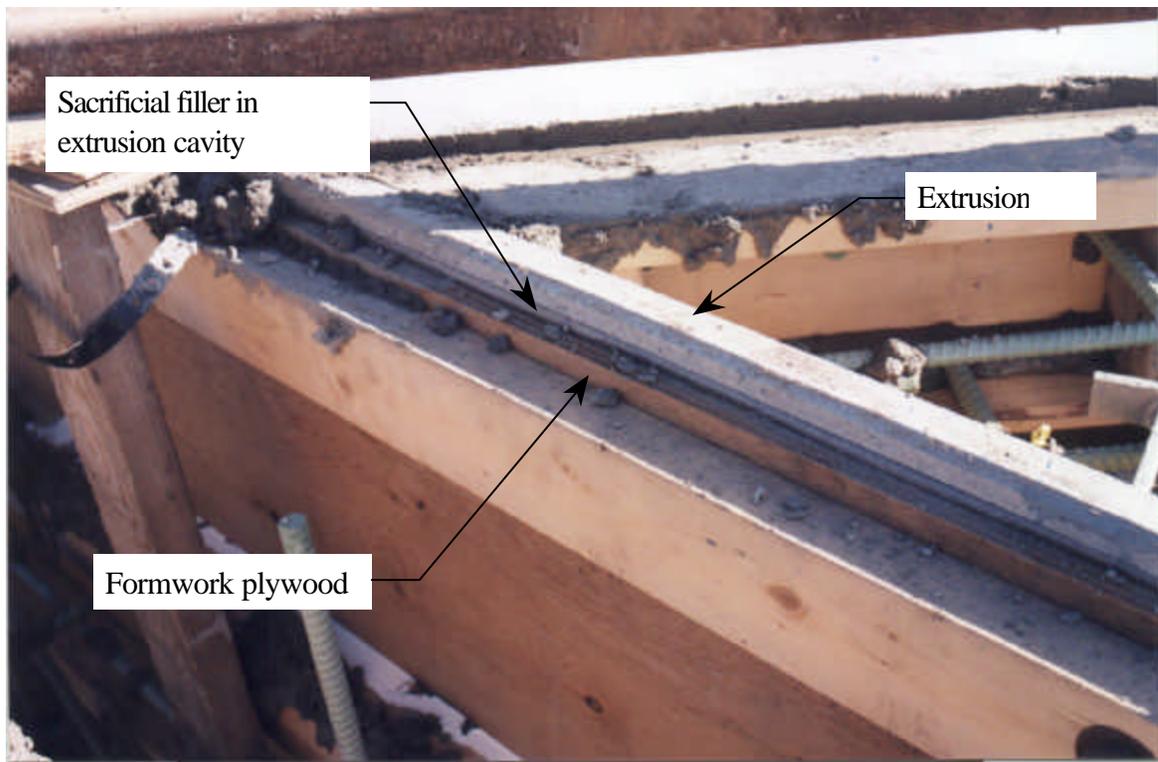
Figure 4.11 Foam backer rod was used to protect the cavity of the west side deck extrusion

On the Highway 5 bridge on the day the deck was cast, the cavity of the west rail was filled with a sacrificial filler (cylindrical pieces of foam or backer rod wedged into the cavity) to keep out concrete and debris during concrete placement and other construction operations (Figure 4.11). The cavity of the east rail was open on the day the north half of the deck was placed (Figure 4.12). Tape is also sometimes used to seal the cavity against concrete and debris. A clean, smooth rail cavity is essential for the efficient installation and ultimate effectiveness of the neoprene seal. Protecting the cavity with a sacrificial filler, tape, or other means can save considerable labor later required to clean out a contaminated cavity. And a contaminated cavity that is not cleaned out can make the efficient and effective installation of the neoprene seal impossible.

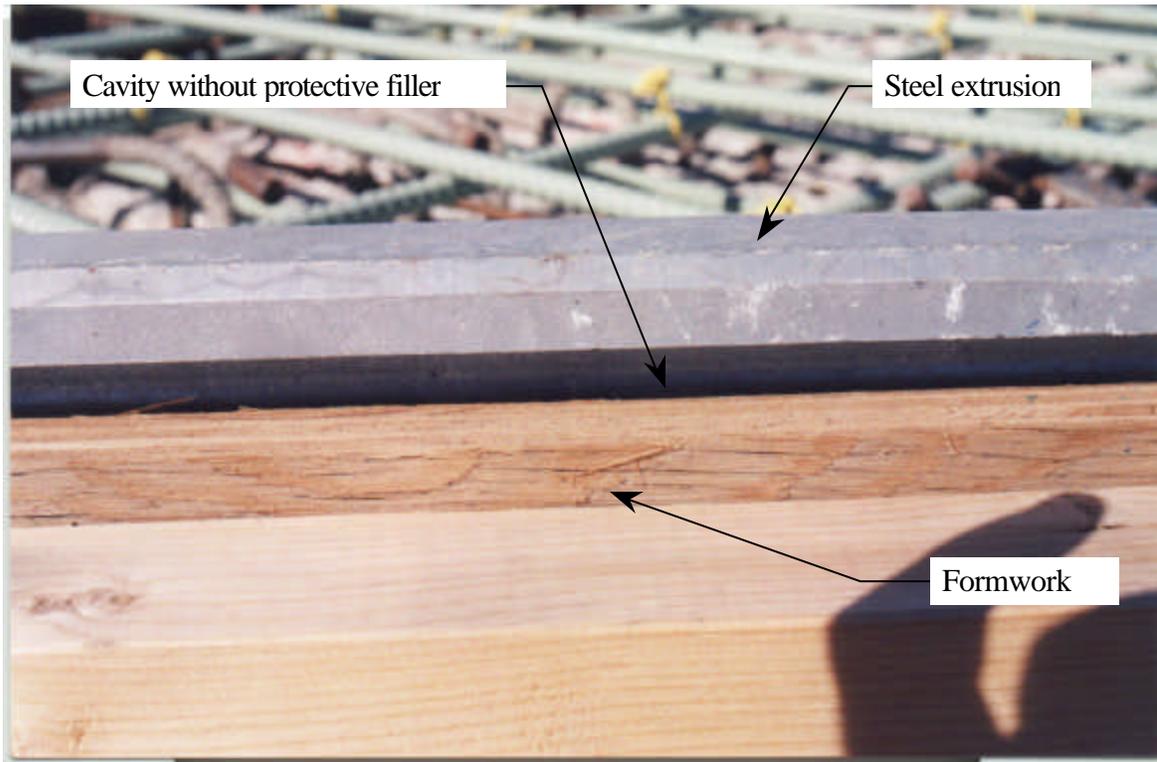
Figure 4.12 No sacrificial filler was present in the cavity on the east end of the deck

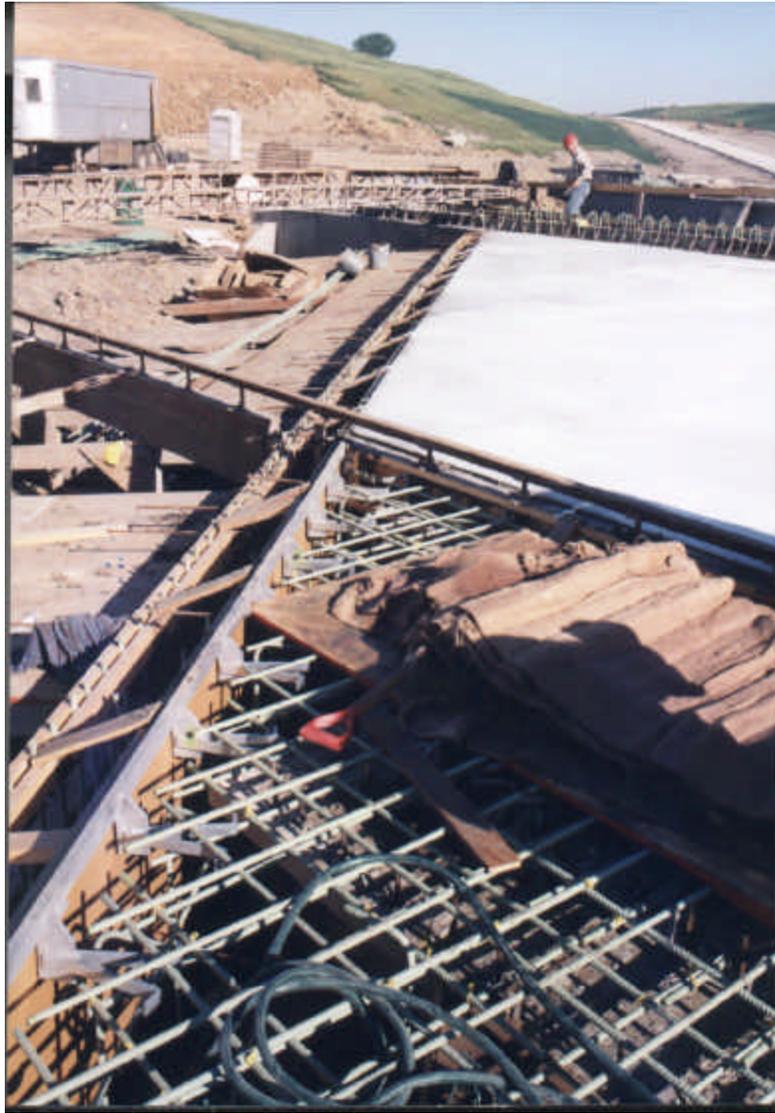
Figure 4.13 North portion of extrusion embedded in concrete

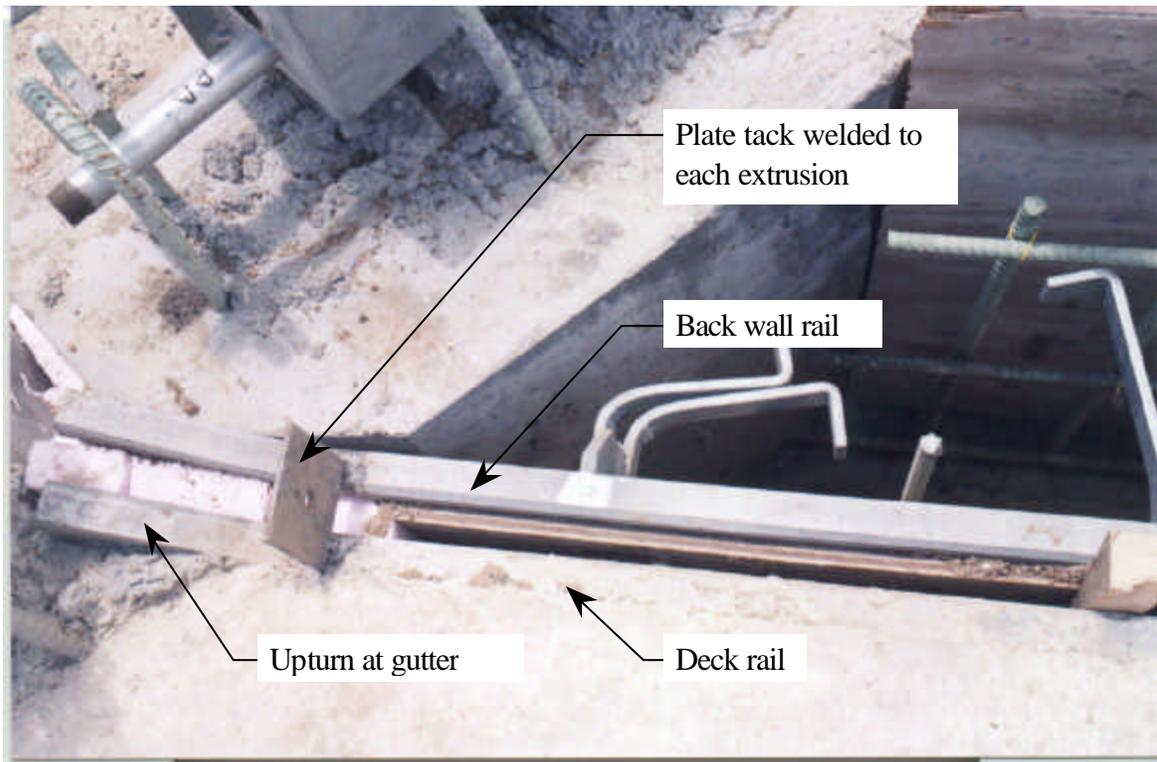
Figure 4.14 Small plates are tack welded to either extrusion to maintain gap

To create a uniform gap between the rails during the casting of the backwalls, a gap size is first selected (the top edge of the backwall formwork has enough play to allow adequate adjustment for this purpose). To maintain the selected gap, small steel plates are placed across the gap and tack welded to both rails (Figures 4.14 and 4.15). The gap is selected based on the gap-versus-temperature values given in the design specifications. For

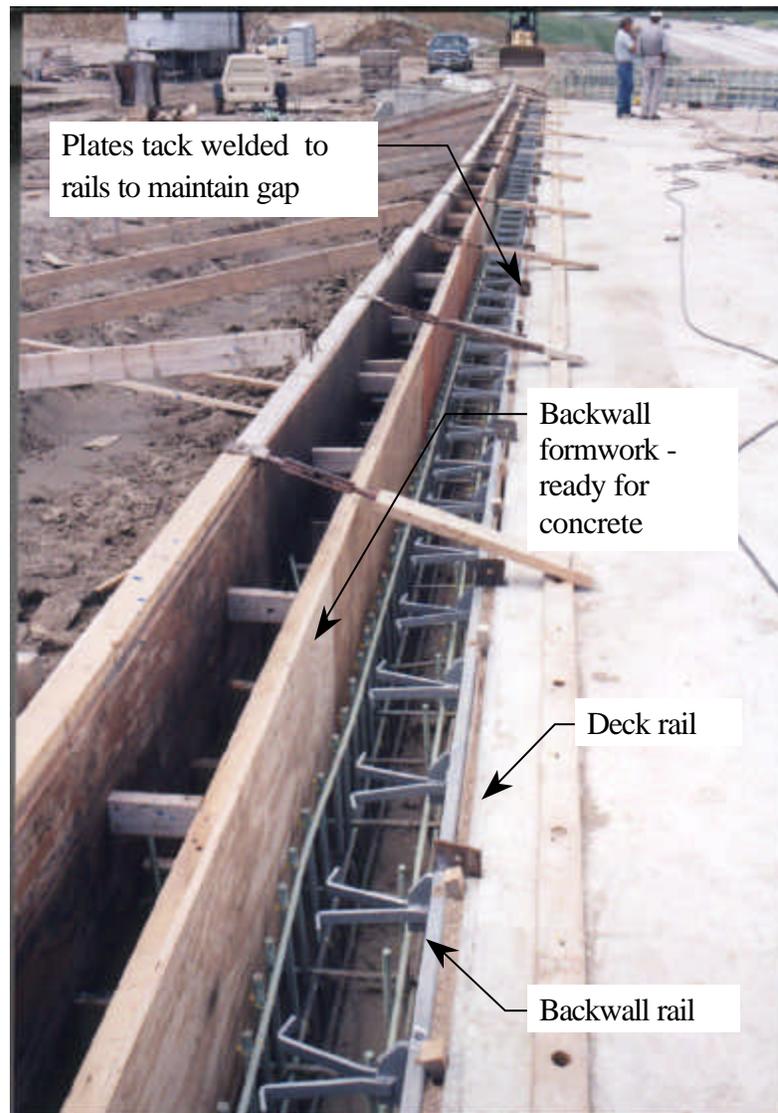
Figure 4.15 West backwall formed and ready for concrete

Sometime after the backwall rails are in place, the backwalls are cast and the anchorages and bottom and backwall faces of the rails are encased in concrete. Using the technique of plates across the gap that are tack welded to each rail (Figure 4.14), the gap setting cannot easily be changed. On the day the west backwall was poured on the IA Highway 5 bridge, the sky remained overcast longer than the weather service predicted. The air temperature at the time of concrete placement was therefore not quite as warm (by 5 to 10 degrees) as had been assumed in setting the gap opening.

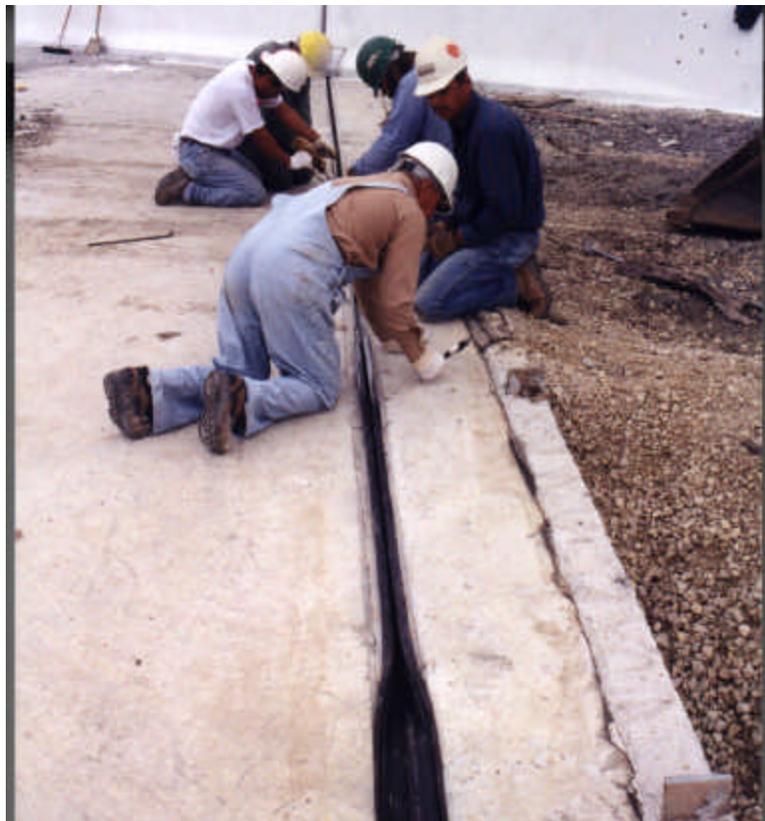
Figure 4.16 Seal is installed in one piece from end to end

After the deck and backwall or deck sections are cast, embedding the two rail anchorages, and the forms have been stripped, the neoprene seal is installed in one piece from gutter to gutter (Figure 4.15). Before the actual installation of the neoprene seal, the cavities in the metal extrusions are cleaned as necessary to ensure that the strip seal will fit into the recesses properly. Cleaning the cavity can be difficult, especially if concrete has run over the rail and entered the cavity. That is the primary reason some contractors use a sacrificial filler in the recess or tape over the cavity to prevent dirt, concrete, and debris from fouling the cavities.

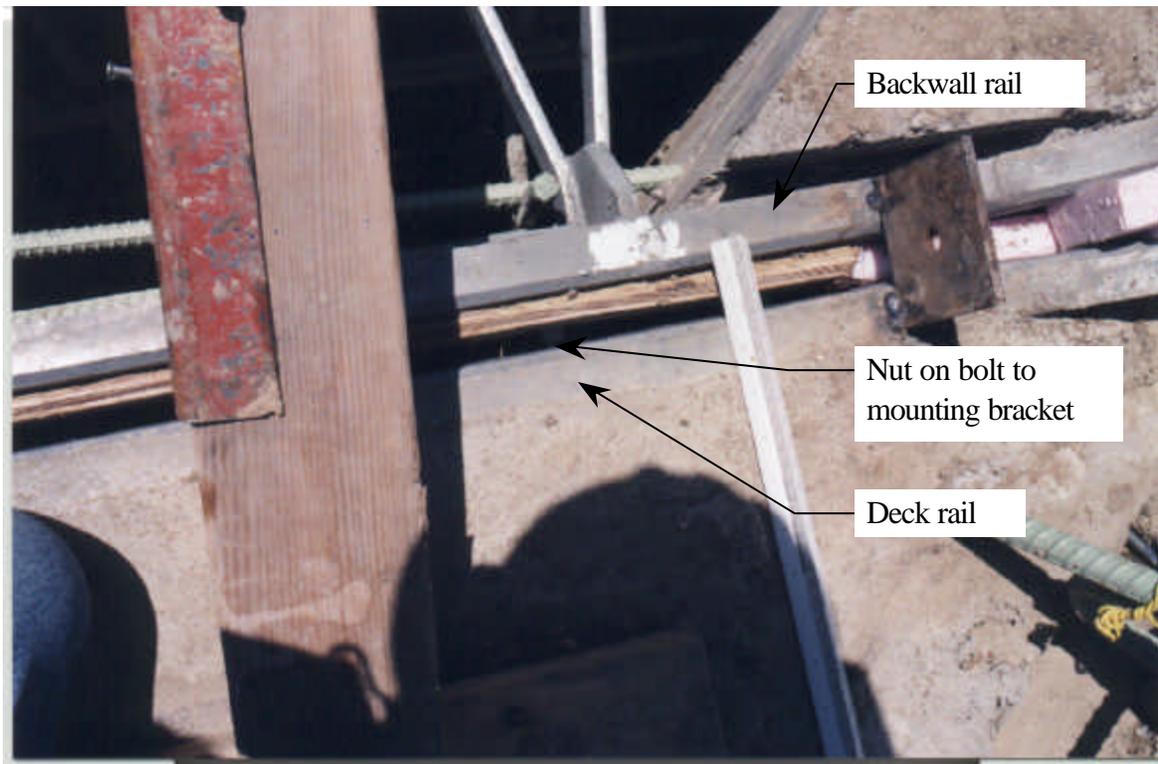
Figure 4.17 There is typically little room to work between the pair of extrusions

Tools for efficiently cleaning the cavity do not seem to be readily available. Since the temperature is typically warm during construction, the gap between the pair of rails is typically small (2 in. or less) and provides little room to work (Figure 4.17). Even when the gap is larger, it is practically impossible to see into the upper portion of the cavity without mirrors or other special optical equipment. Cleaning of much of the cavity must therefore be

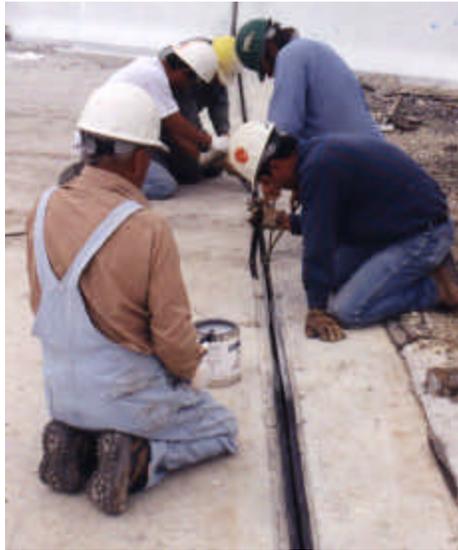
Figure 4.18 Installation requires working in small increments

To install the neoprene seals on the IA Highway 5 bridge the seal was first cut to length and then folded in the middle with the lugs up. Then the bottom “V” was pushed into the expansion joint opening with a metal bar (e.g., a pry bar or seal installation tool) such that the lugs were resting flat on top of the extrusions (Figures 4.16 and 4.18). Next, lubricant/adhesive was applied to the seal lugs with a paint brush. The seal was then pushed further down into the expansion joint opening until the two outer ears of the lugs caught on the opposing rail cavities (Figure 4.2). Then two installers, one working on each side of the joint and each with a pair of prying tools, forced the upper ears of the lugs into each rail cavity. The prying action to push the upper ears into the cavity was done in alternating fashion with the pair of tools and in increments of 2 to 3 in. The installers said the best test of whether or not the upper ear was completely seated was the appearance of the seal. They said there was generally no particular sound or feel when the upper ear became fully engaged. The lubricant/adhesive was applied 3 to 5 ft ahead of the installers (Figure 4.18).
